Reservoir Survey for Invasive and Native Aquatic Plants Species within the Pat Harrison Waterway District

A Report to the Pat Harrison Waterways District

Wilfredo Robles, John D. Madsen, and Victor L. Maddox
GeoResources Institute and Department of Plant and Soil Sciences
Mississippi State University
Box 9652
Mississippi State, MS 39762-9652
February 15, 2008

GeoResources Institute Report #5018
Mississippi State University, Mississippi State, MS

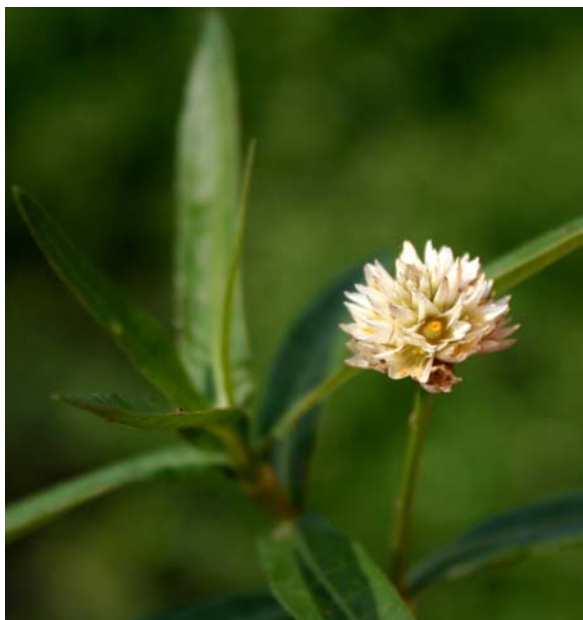
Description – Commonly known as alligatorweed, it is an herbaceous perennial which is commonly found along shorelines. It has opposite simple linear leaves with a whitish inflorescence growing from leaf axils. Its growth form is emergent attached to the sediment. Stems can creep over the water, produce adventitious root and anchor in the sediment which consequentially facilitates its spread. A distinctive morphological characteristic is having a hollow stem which provides buoyancy. Alligatorweed has been implicated in the reduction of light penetration in the water column adversely affecting native submersed plant

growth (Cronk and Fennessy 2001). See Table 8 for plant locations and its geographic coordinates.

Control Methods – The use of biological and chemical control in an integrated management approach has been recommended for alligatorweed (Durden et al. 1975). The most effective biocontrol agent is the flea beetle, *Agasicles hygrophila* which is well established in southern states. However, biocontrol alone is not a long term solution and should be alternated with chemical control. Currently, alligatorweed is not widespread in Flint and Big Creek and is mainly located at boat ramps and small coves. This means that chemical control using spot treatments of herbicides is the most reliable control method. The herbicide 2, 4-D at a rate of 2 quarts of product per acre foliar applied has been recommended for alligatorweed control (Durden et al. 1975, Table 9 and 10). In the state of Florida, an application of 2, 4-D per acre costs \$98.50 (Mossler and Langeland 2006). It is important to know that 2, 4-D does not have restrictions for recreational use (e. g. swimming) which is good for this water body (Table 9).

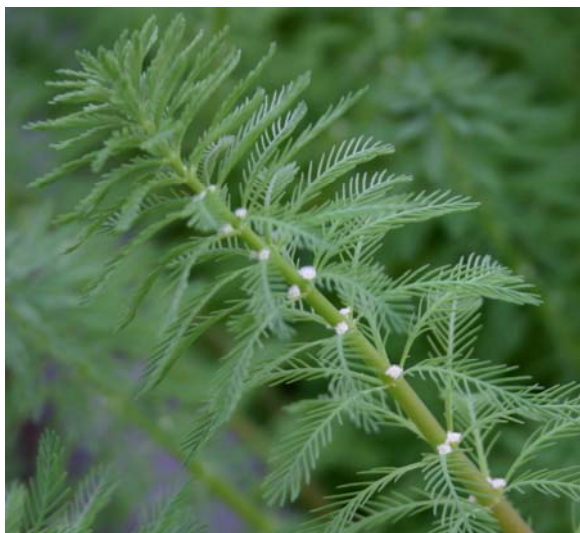
Description – Commonly known as parrotfeather, is a submersed plant attached to the sediment and able to emerge from the water. This characteristic facilitates its growth providing better light interception and gas exchange. Leaves are dissected, featherlike and arranged in whorls around the stem with a distinctive grayish green color. Emergent portions can creep over the water, produce adventitious roots and anchor in the sediment which consequentially facilitates its spread. Parrotfeather has been implicated in providing refuge for mosquito

breeding, and chokes water bodies limiting water flow (Wersal and Madsen 2007a). See Table 8 for plant locations and its geographic coordinates.

Control Methods – Biological, chemical and mechanical control are suggested alternatives for parrotfeather control. However without promising effectiveness, chemical control is the only effective measure (Wersal and Madsen 2007a). Herbicide recommendations and water use restrictions are shown in Table 9 and 10. Since populations of parrotfeather at Archusa Creek are as low as 1.39 % frequency occurrence, spot treatments with imazapyr are recommended. Although other herbicides are recommended (Table 10), imazapyr has shown excellent results in reducing plant

biomass (Wersal and Madsen 2007b). Spot treatments of imazapyr should be carefully done because non-target vegetation such as grasses may be injured.

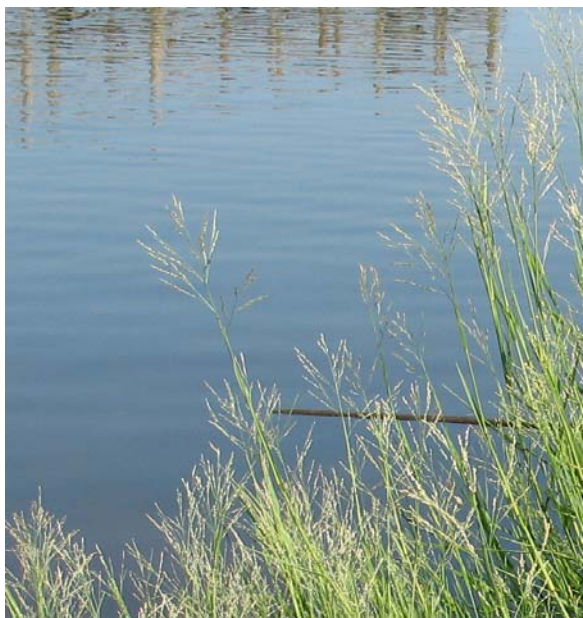
Description – Commonly known as torpedograss, it is a perennial rhizomatous graminoid commonly found along shorelines. It has glabrous leaf blades (no hairs) and flowers are contained in a panicle. Stems can reach up to 2.5 feet tall and surface runners form solid colonies facilitating its establishment and spread.

Torpedograss has been implicated in

displacing native aquatic vegetation and infesting golf courses (Langeland and Craddock Burks 1998).

Control Methods – Control programs for torpedograss should use recommended herbicides (Table 10). In the state of Florida, an application of glyphosate costs \$120.00 per acre (Mossler and Langeland 2006). Spot treatments of glyphosate in Little Black Creek should be carefully done because non target vegetation such as grasses may be injured.
